MACON LAKE DAM
MACON COUNTY, MO.
MO 10153

PHASE 1 INSPECTION REPORT NATIONAL DAM SAFETY PROGRAM

PREPARED BY: U.S. ARMY ENGINEER DISTRICT, ST. LOUIS

OCTOBER, 1980

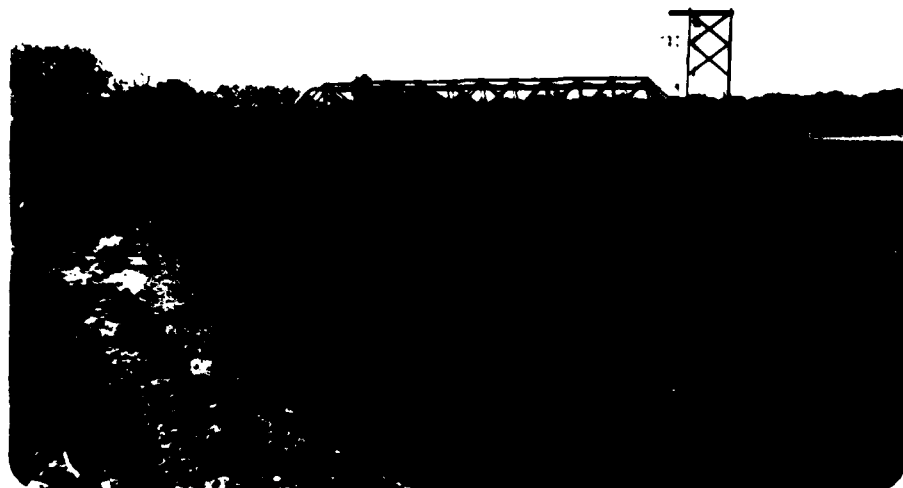
The upstream slope and riprap are shown in Photos 3, 7 and 31. Two small slump or eroded areas were noted on the slope between Stations 3+80 to 4+10 and around Station 5+20. These areas occur just above the riprap and have been stabilized with riprap and rubble. Photo 8 shows one of the slump or eroded areas. No other significant erosion was noted along the upstream slope. No cracks or deformations were observed on the slope. Measurements indicated that the slope is flatter than shown on the plans (1V on 2.4H vs 1V on 2.0H). The large oak tree shown in Photo No. 27 is rooted in the right abutment and should not be of concern.

PHOTO NO. 3 - UPSTREAM FACE FROM LEFT END

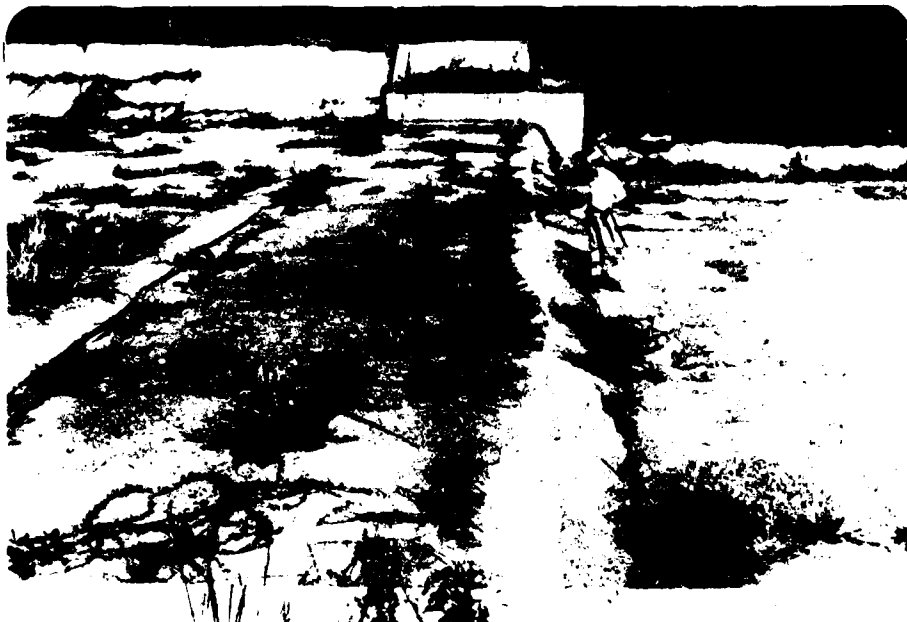
Some cracking and deterioration was observed in the drop structures as shown in Photos 20, 21, 23 and 25.

PHOTO NO. 20 - LOOKING RIGHT TO LEFT ACROSS FIRST DROP IN
SPILLWAY CHUTE

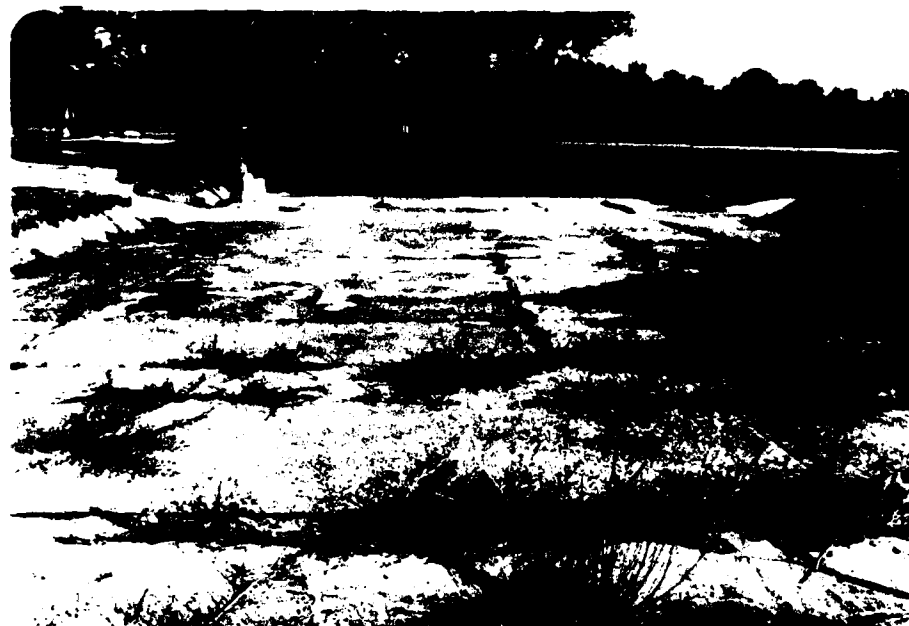
The concrete in the two sections downstream from the first (original) section is in better condition than that in the first section. Considerable surface scaling and some spalling in the joint cracks was observed. Photos 22, 24 and 26 show the lower two sections of the spillway channel.

PHOTO NO. 22 - LOOKING DOWNSTREAM OVER TOP OF FIRST DROP
IN SPILLWAY CHUTE

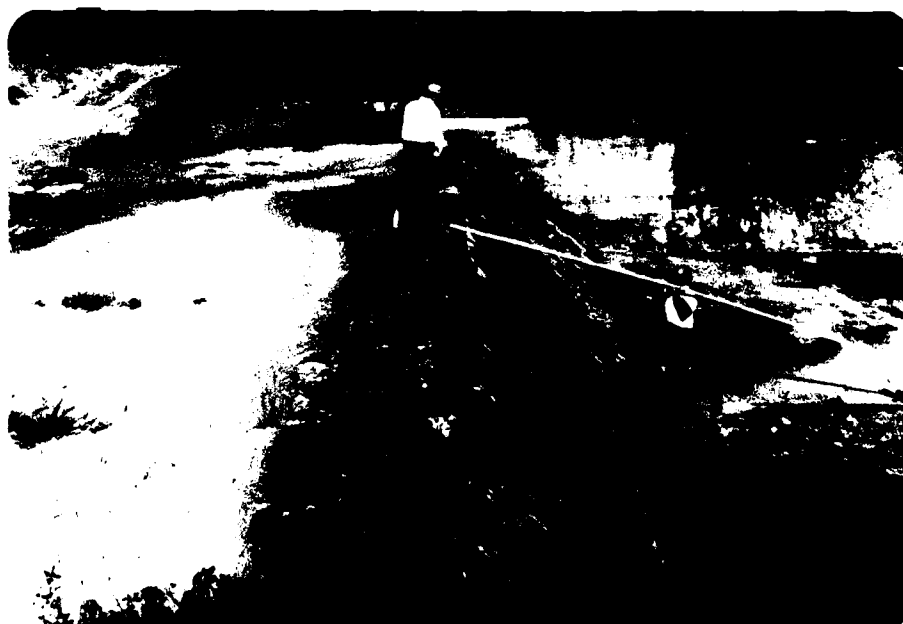
PHOTO NO. 23 - LOOKING RIGHT TO LEFT ACROSS SECOND DROP
IN SPILLWAY CHUTE

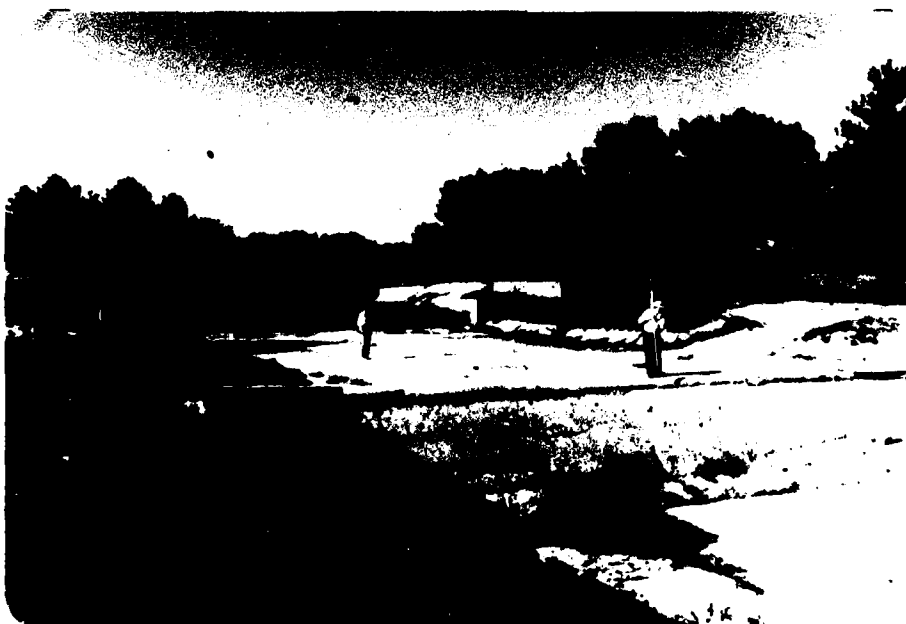
PHOTO NO. 25 - LOOKING UPSTREAM AT SECOND DROP IN SPILLWAY
CHUTE
